Toronto stadium renovation requires heavy machinery

Pair of lattice-boom crawlers from Mammoet lifts BMO Field canopies into place

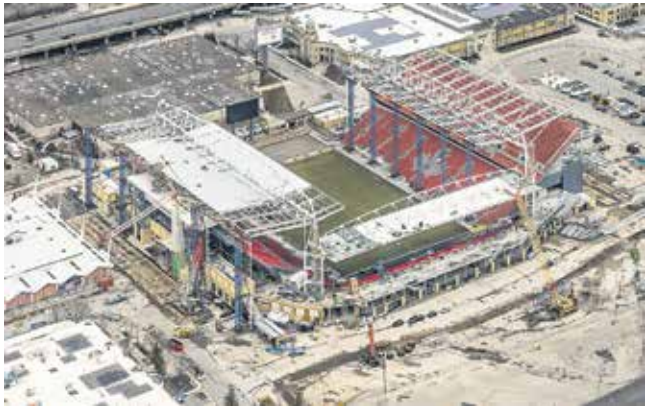
Aerial view shows progress on crane work during renovation of BMO Field. Photo courtesy of PCL Constructors Canada Inc.

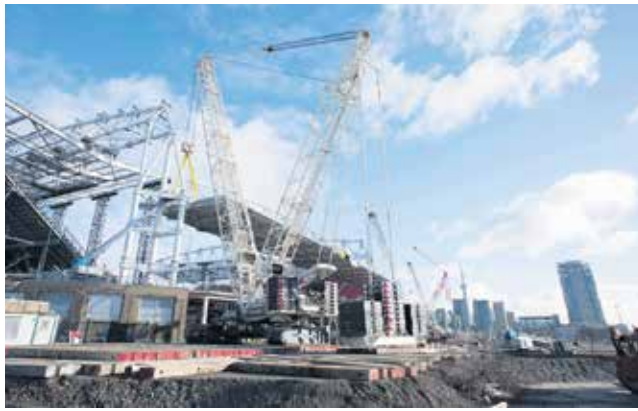
Mammoet Canada Eastern uses two Demag crawlers to install a canopy at Toronto's BMO Field. Photo courtesy of Canam-Heavy

Mammoet Canada Eastern supplied two lattice-boom cranes to lift the canopies.

A Terex Demag CC2800, a 600-tonne crawler, handled the east side, and a Terex Demag CC2400, a 400-tonne crawler, worked the west side. Crews then used both cranes to tandem lift the 490 U.S. ton south canopy into place.

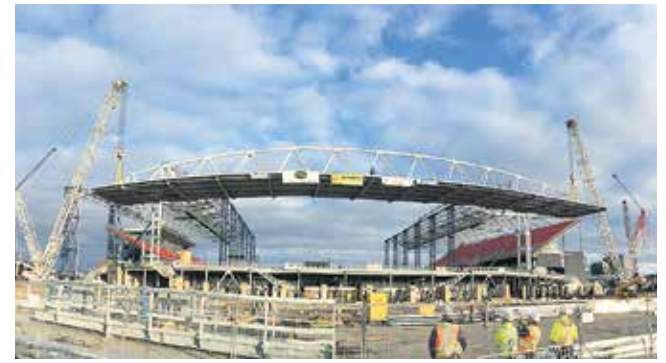
Camera captures wide-angle view of tandem lift of roof canopy during renovation to Toronto's BMO Field. Photo courtesy of PCL Constructors Canada Inc.

The tandem lift was an especially challenging job. Crews assembled all canopies on site, but the south one was enormous — 115 metres long, 21 metres wide and 23 metres high. The two lattice-boom crawlers lifted and literally crawled it to where it could be incorporated into the overall roof structure.

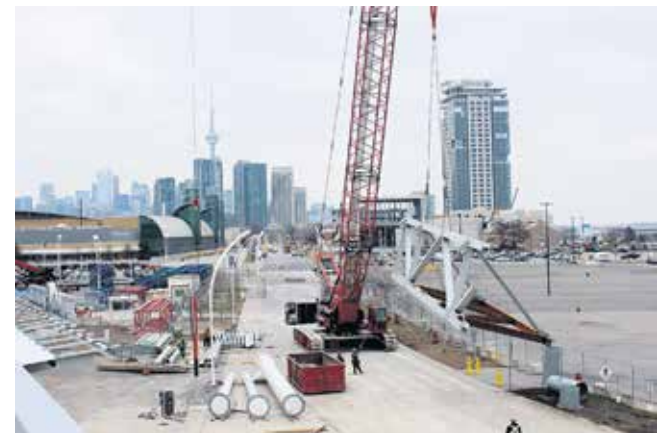
Crawler works on BMO Field renovation with Toronto city skyline as a backdrop. Photo courtesy of PCL Constructors Canada Inc.
